**GEOTECHNICAL ENGINEERING REPORT
TONAWANDA CREEK ROAD
SLOPE STABILIZATION PROJECT**

**TOWN OF CLARENCE,
ERIE COUNTY, NEW YORK**

November 2004
File: 04-013

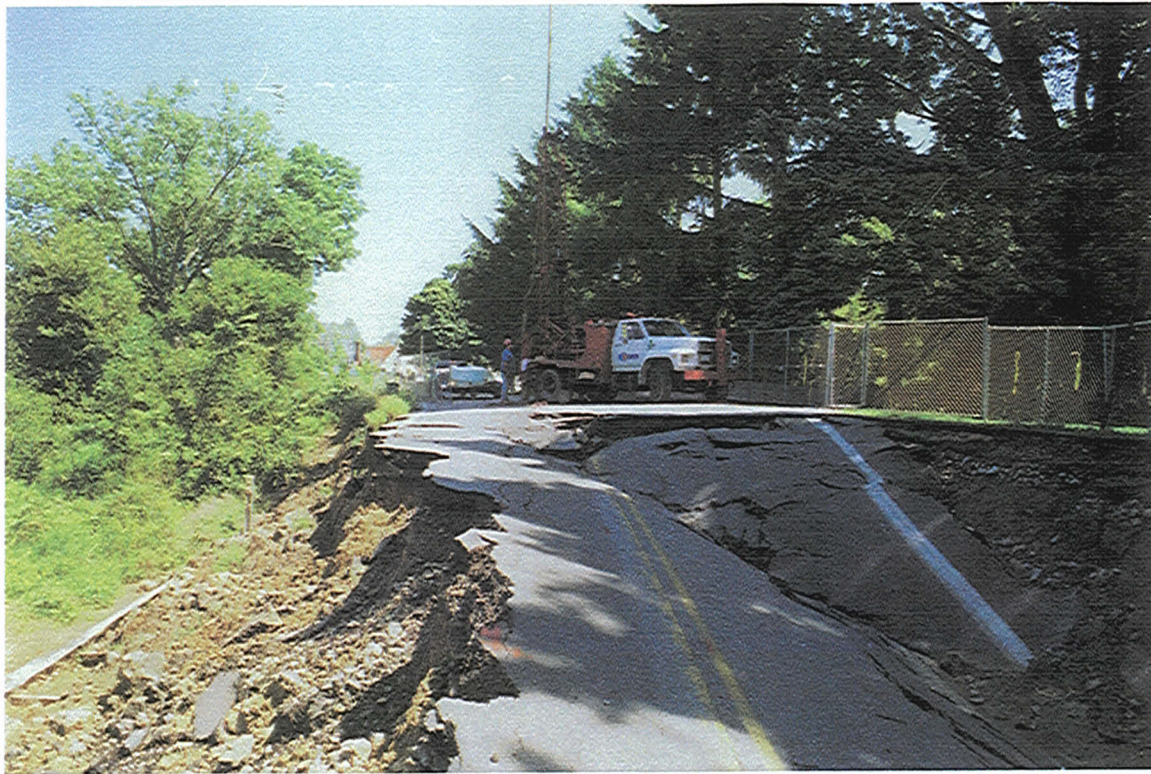
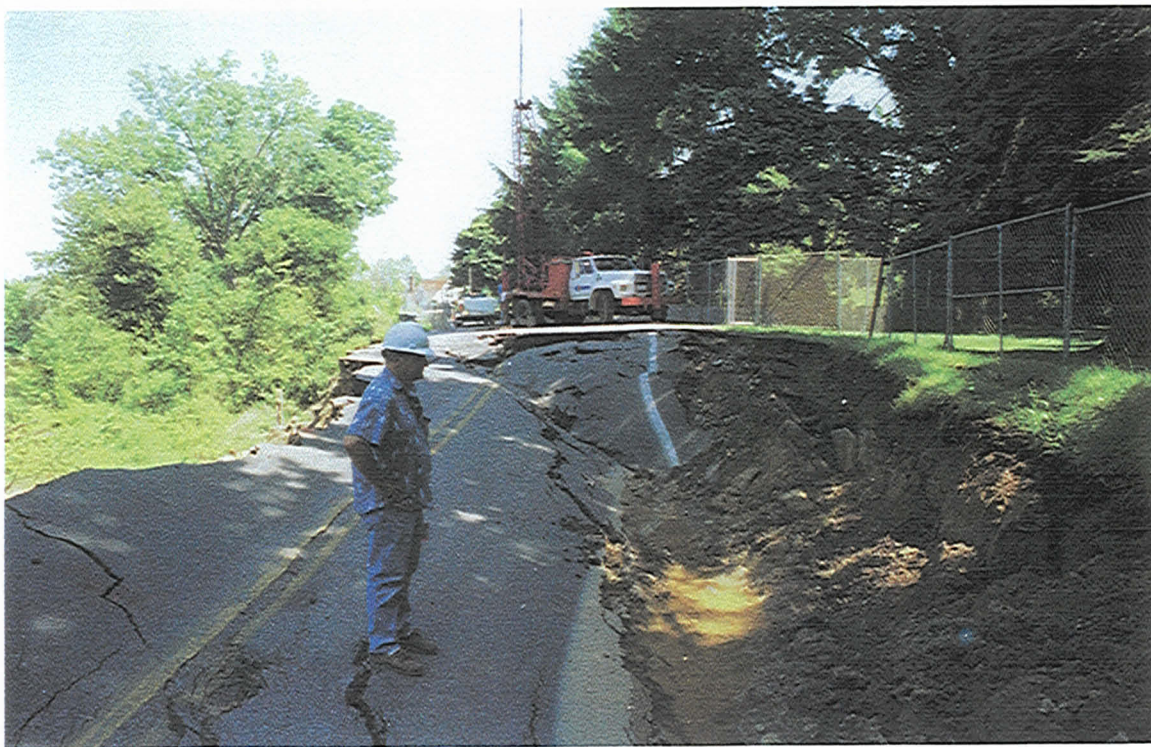
Figure 9 - Collapse area looking East.
Photos taken 8/2/04

At this site, Tonawanda Creek Road is oriented approximately in an east-west direction, (see Figures 2 and 3). The area where the road has collapsed is on an outside bend in the creek similar to other failure locations along the creek. The collapsed area is approximately 250 feet long however the affected area extends a few hundred feet beyond each side of the collapse area. The photos on Figure 9 show the failure area.

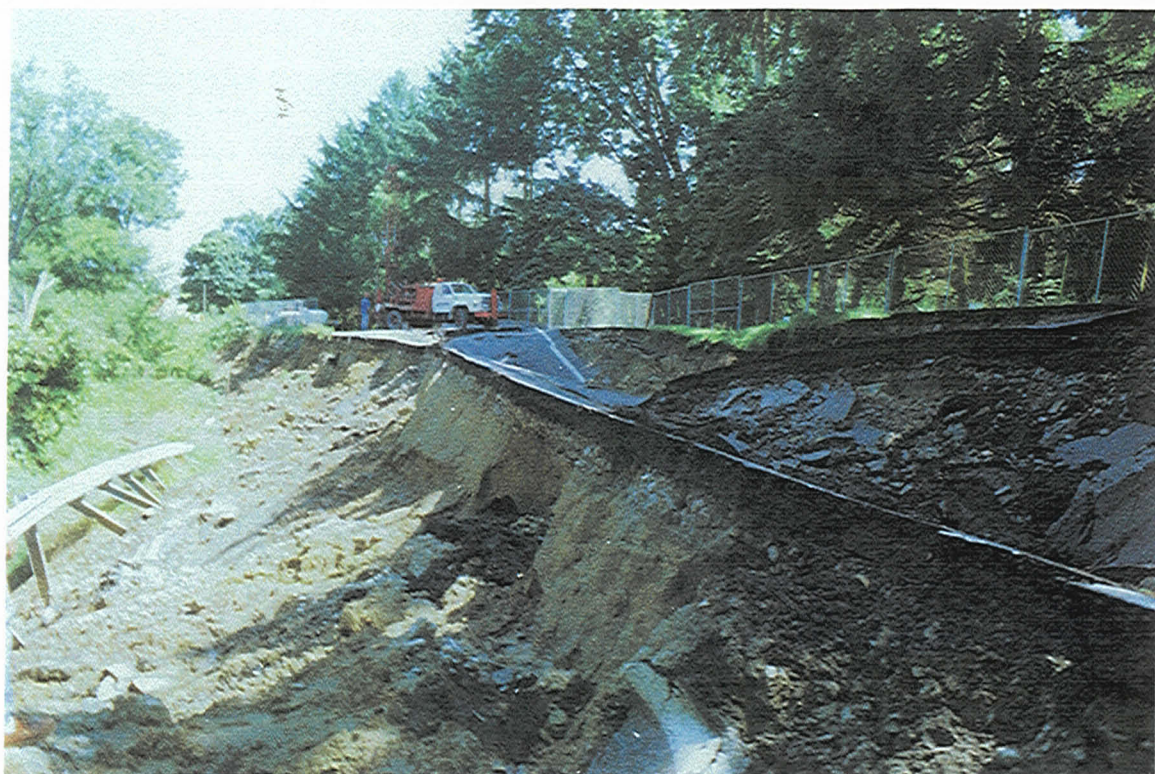
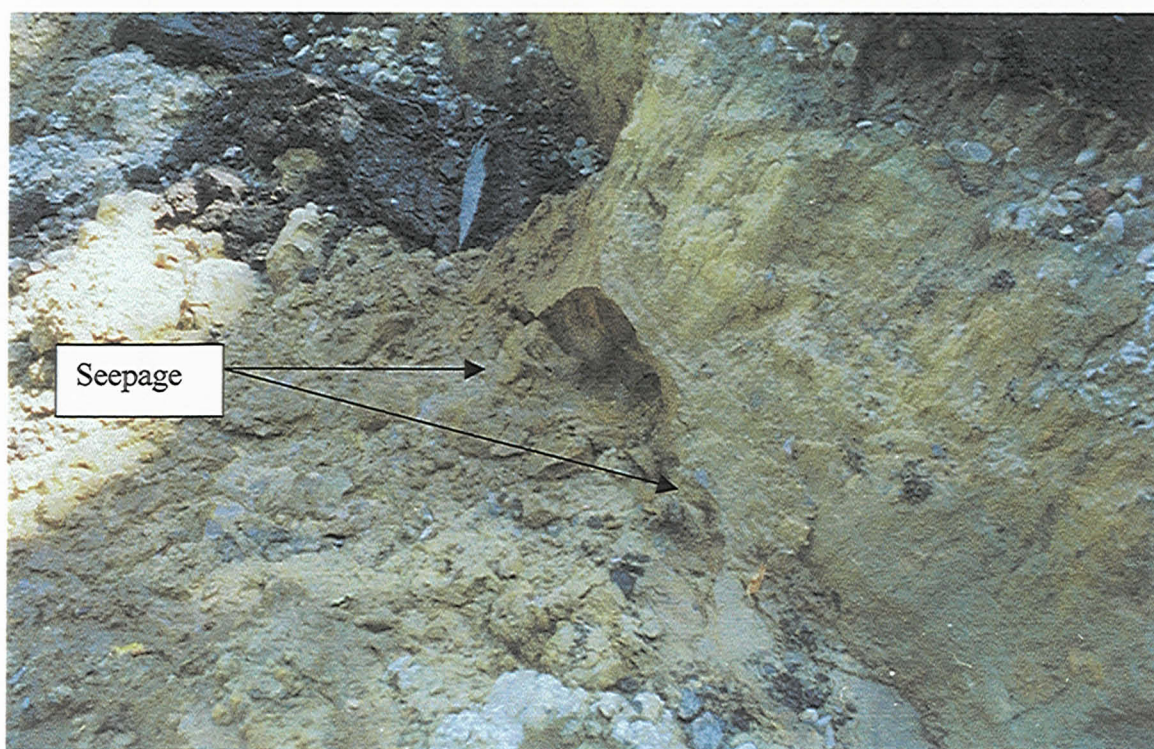
Figure 10 – Scarp, note water seeping from slope.
Photos taken 8/2/04

The road surface in the portion of the road that has not failed is approximately elevation (El.) 587 feet (178.9 meters). The scarp in the failure area is about 10 feet (3.1 meters) high and the face consists of silty sand to sandy silt. MMCE observed water seeping out of the face of the scarp at several locations (see photos on Figure 10). Ponded water, in the area south of the failure area, could be infiltrating into the ground and seeping out of the face of the scarp.

Photos taken on June 25, 2004 (Figures 12 and 13) show that the failure started as a relatively small failure involving the northern shoulder of the road. In our opinion, a build up of water pressure in the silty sand deposit overlying the soft clay likely led to the initial failure. Evidence of water seeping out of the silty sand could still be observed days after the failure, as shown on Figure 10.

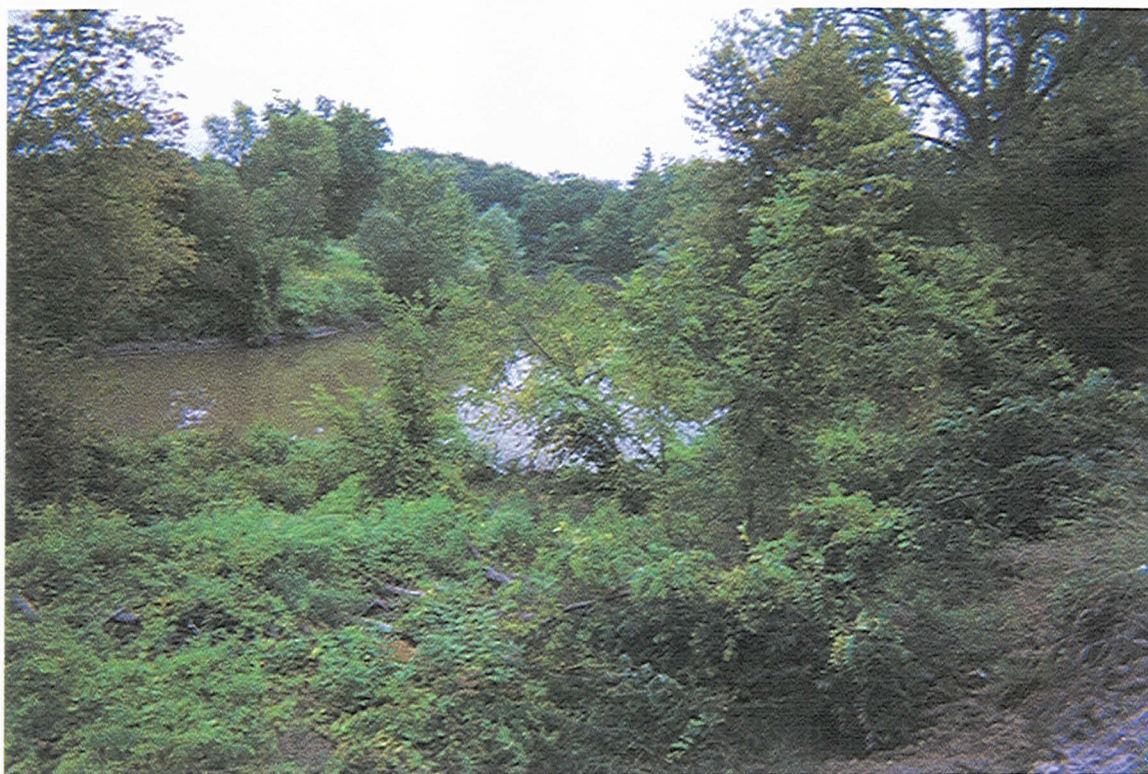
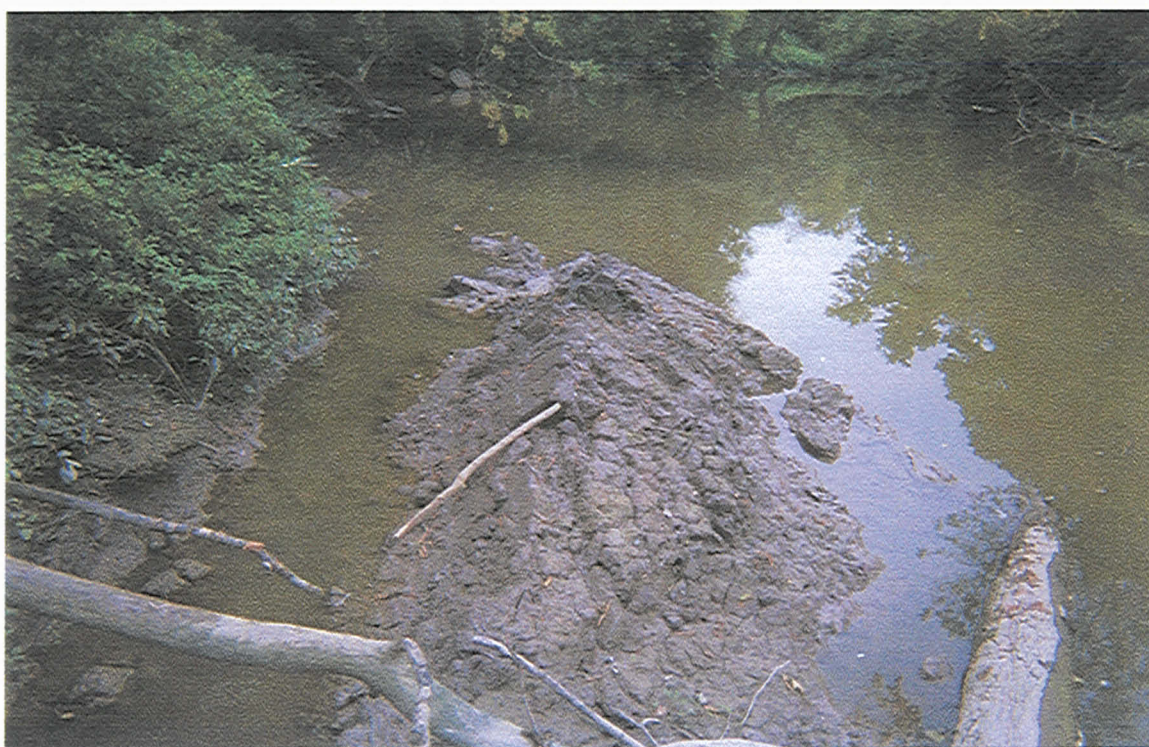
Figure 11 – Showing area between road and creek and soil in creek.
Photos taken 8/2/04

The area between the road and the creek is about 40 to 60 feet (12.1 to 18.3 meters) wide and ranges in elevation from about El. 575 feet (175.3 meters) to about El. 570 feet (173.7 meters). This area was pushed out into the creek during the slope failure creating the bulge shown on Figure 2. The area is vegetated with brush, grass and trees. Several tree trunks lean back into the slope indicating ground movement at their bases.

On September 23, 2004, the day of the site survey, the creek was at El. 568 feet (173.2 meters). We observed a mound of soil pushed up into the creek as shown on the photos in Figure 11. The ground contours on Figure 2 show that the creek bottom is mounded up in the vicinity of the failure to about El. 565 feet (172.2 meters) and that the creek is constricted in this area. Upstream and downstream of the failure area, the low point in the creek bed is about El. 560 feet (170.7 meters).

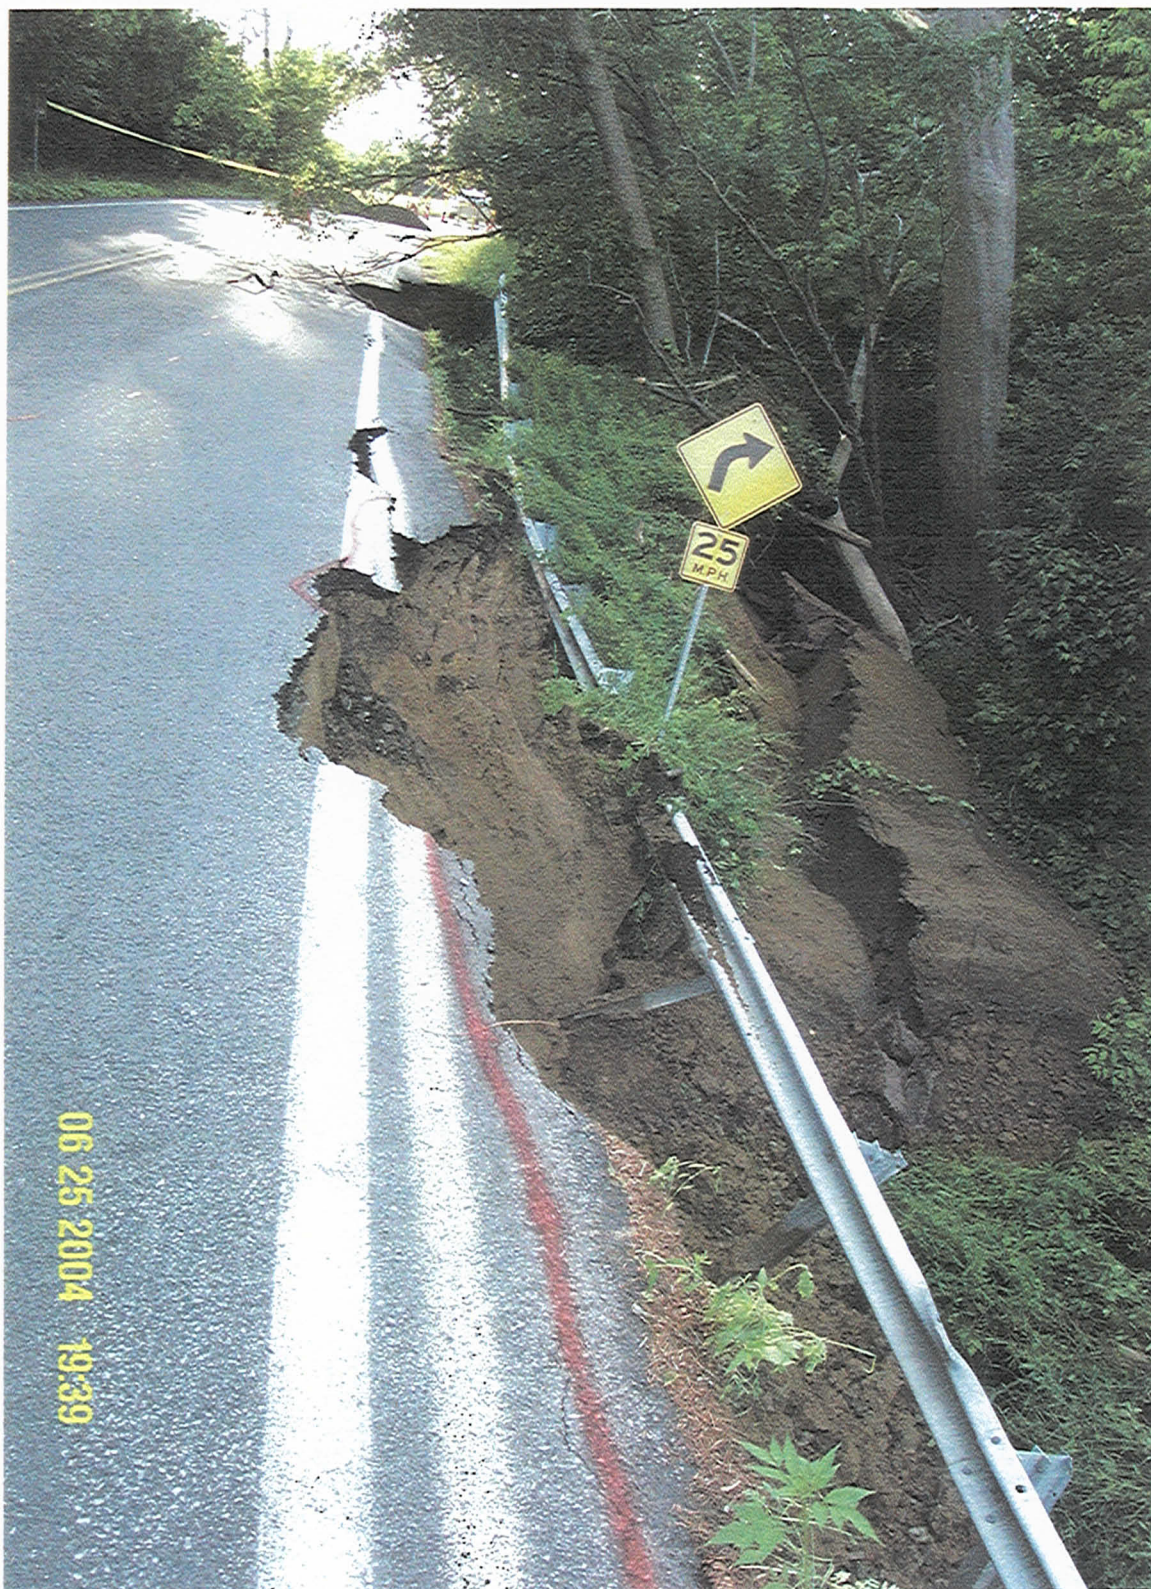
Figure 12 – Looking West at failure.
Photo taken 6/25/04

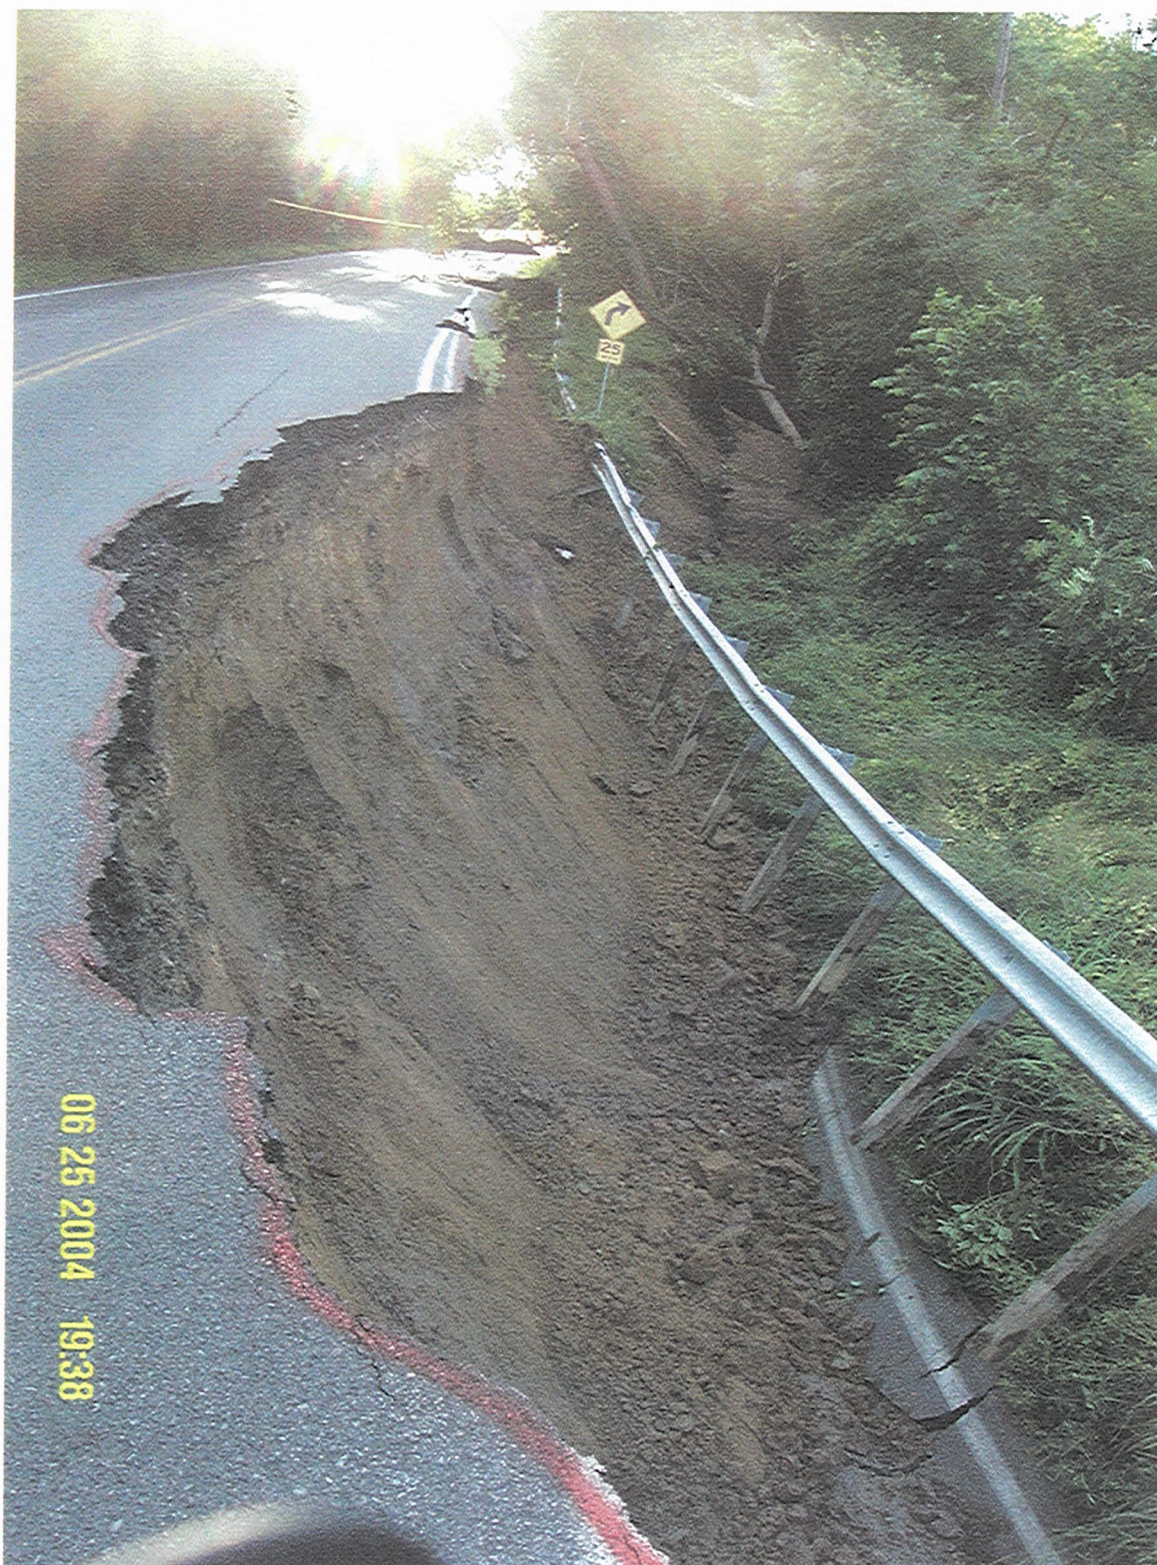
Figure 13 – Looking West at failure.
Photo taken 6/25/04
